04/2006 Product Alert: Defective IPD front sway bars

An important issue has come to our attention regarding IPD sway bars for the following models:

- 93-97 850
- 98-04 C70
- 98-00 S70
- 98-00 V70

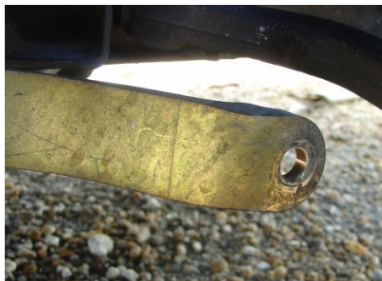
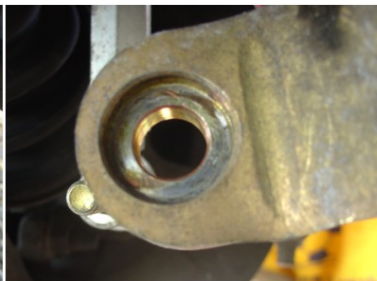
Early generation IPD sway bar kits for the models listed above had a manufacturing defect with the front sway bar. The hole at the end of the sway bar where the endlink mounts is supposed to be 10mm (3/8") – the size of the stock endlink stud. The hole in the defective IPD sway bar is 1/2" instead. Since the sway bar hole is larger than the endlink stud/bolt, problems may arise ranging from front-end noise to endlink bolt/stud failure.

To determine if you have one of the affected front sway bars, turn your wheel fully to one side where you will be able to identify the sway bar inside the wheel well. The affected IPD front sway bar is GOLD plated and has 5/8" thick ends with a machined counter bore where the sway link mounts. The corrected sway bars are powder coated BLACK and have thin 1/4" "blade" style ends where the sway link mounts.

Affected IPD bar

QBM has developed a reinforced hole adapter that adapts the hole in the IPD sway bar to the correct 10mm (3/8") size. Because customer service is our #1 priority, QBM will provide a repair kit free of charge to all customers who purchased a QBM performance sway bar link kit and who have the defective IPD front sway bars on their vehicle.

If you have an IPD sway bar kit on your vehicle, and it is one of the above listed models, please check your vehicle ASAP to determine if you have the defective front sway bar. If so, contact QBM or IPD to acquire the corrective parts and install them immediately to prevent further issues. Installation instructions are provided, and the repair takes less than 30 minutes with basic hand tools.

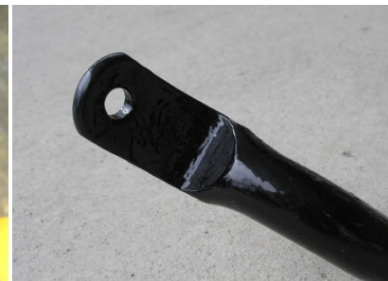
Corrected IPD bar
